August 1993

93-5 TECHNICAL REPORT

Analysis of the TRIGA Reactor Pool Water

Armed Forces Radiobiology Research Institute 8901 Wisconsin Avenue Bethesda, Maryland 20889-5603

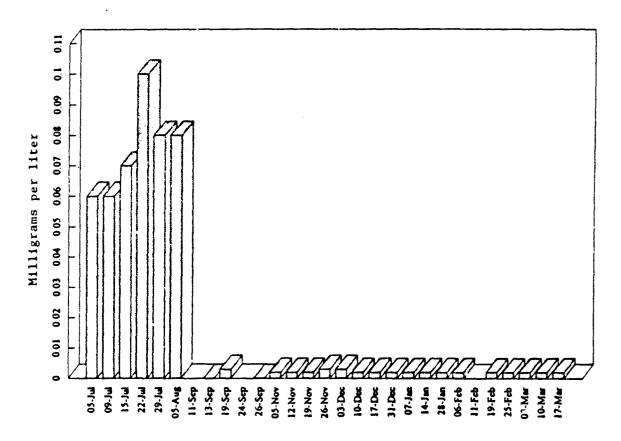
Figure A-2. Nitrite in reactor pool water, July 1991 through March 1992.
